AERIAL PHOTOGRAPHIC AND FRACTURE TRACE ANALYSES OF CHLOR-ALKALI FACILITY

Berlin, New Hampshire

EPA Region 1

TS-PIC-20801101S
February 2008

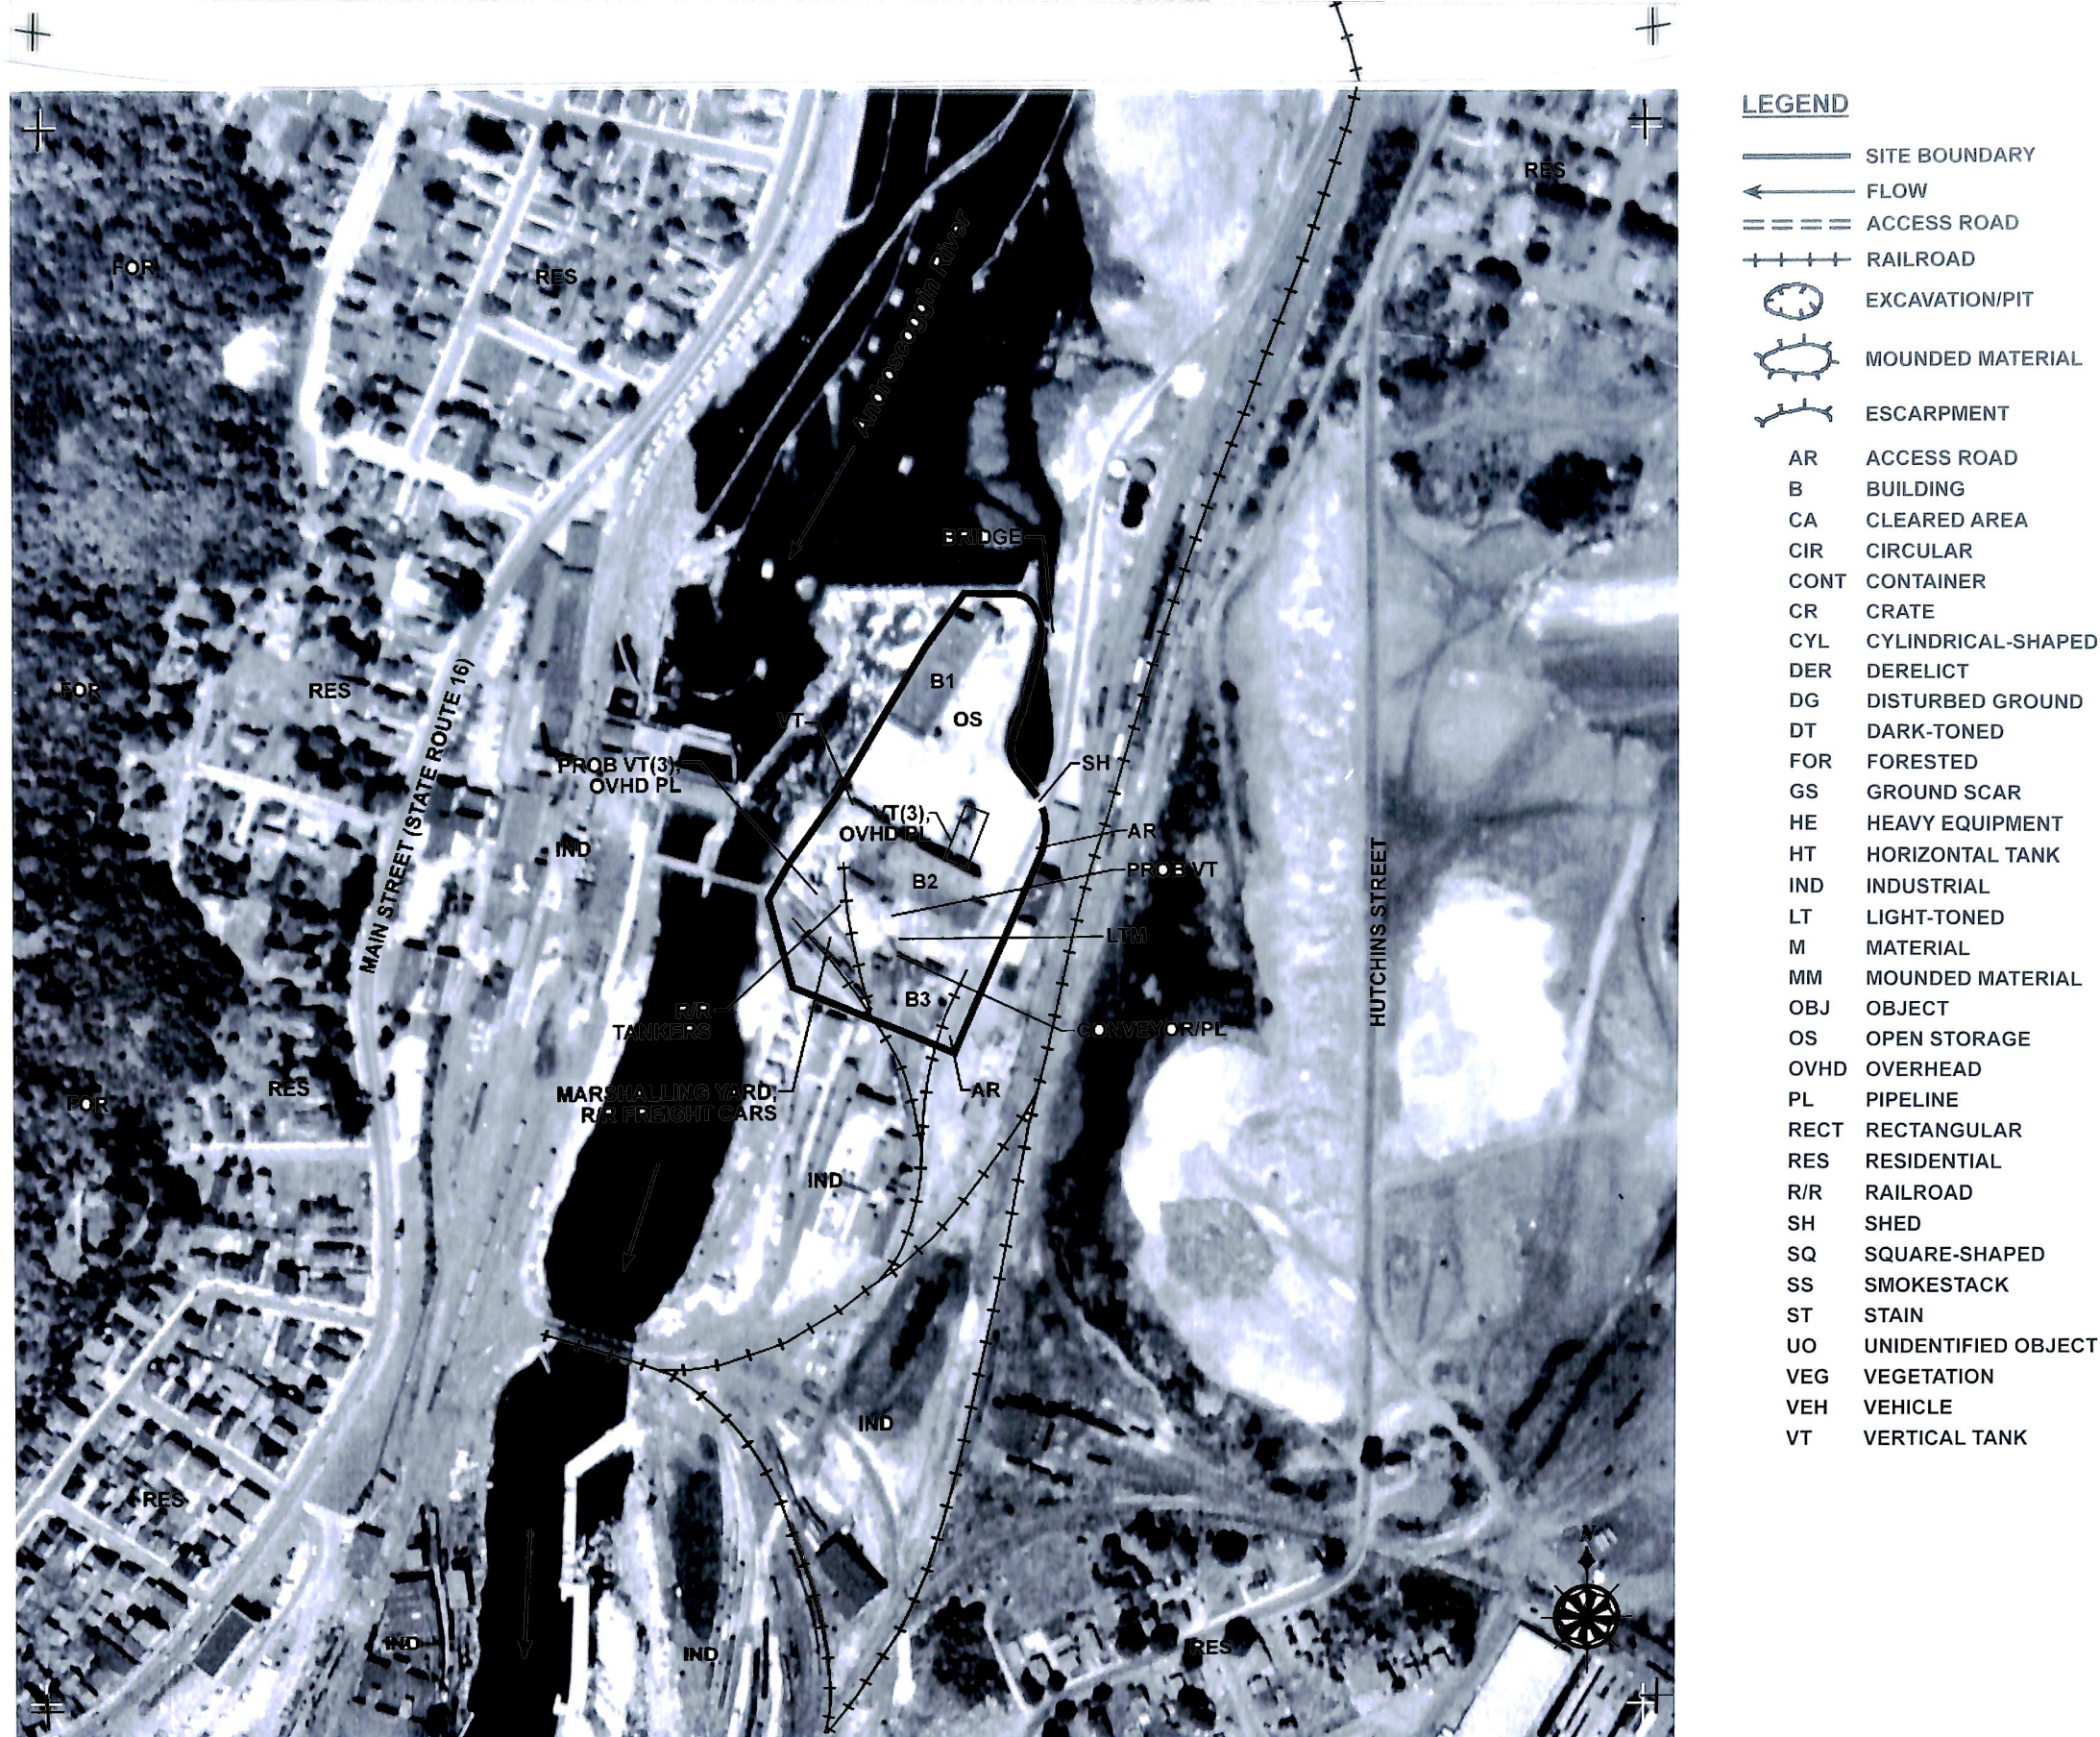
Figure 5. Chlor-Alkali Facility, August 4, 1955. Approximate scale 1:3,600.

AUGUST 4, 1955 (FIGURE 5)

Structures which appear to be associated with an industrial processing facility are on the site. These structures consist of three large buildings (B1, B2, and B3), a small shed (SH), and numerous storage tanks. Access to the site is via a railroad (R/R) system and a north-south oriented access road (AR) that extends along the eastern boundary of the site north to Bridge Street. The access road will no longer be annotated or discussed in the text. Several railroad spurs, railroad freight cars and tankers, and a railroad marshalling yard are located in the southern part of the site.

Near building B1, located in the northern part of the site adjacent to the Androscoggin River, there is an open storage area (OS) containing light-toned objects (not annotated). In the northeast corner of the site there is a walking bridge. Building B2, located in the center of the site, appears to be an assemblage of numerous connected smaller buildings, amassed during past expansions. The smaller individual buildings have roof designs of different heights and shapes. Adjacent to building B2 are a vertical storage tank (VT), a probable vertical storage tank, and along the north side of the building a grouping of three vertical storage tanks. The largest of these three tanks is an open-topped tank. An overhead pipeline (OVHD PL) connects this grouping of storage tanks to building B2. A grouping of three probable vertical storage tanks and overhead pipelines is located between building B2 and the railroad marshalling yard. This area is likely used as a loading zone. In the

southeast corner of the site is building B3. A conveyor/pipeline connects this building to building B2. Also noted between these buildings is a circular patch of light-toned material (LTM).

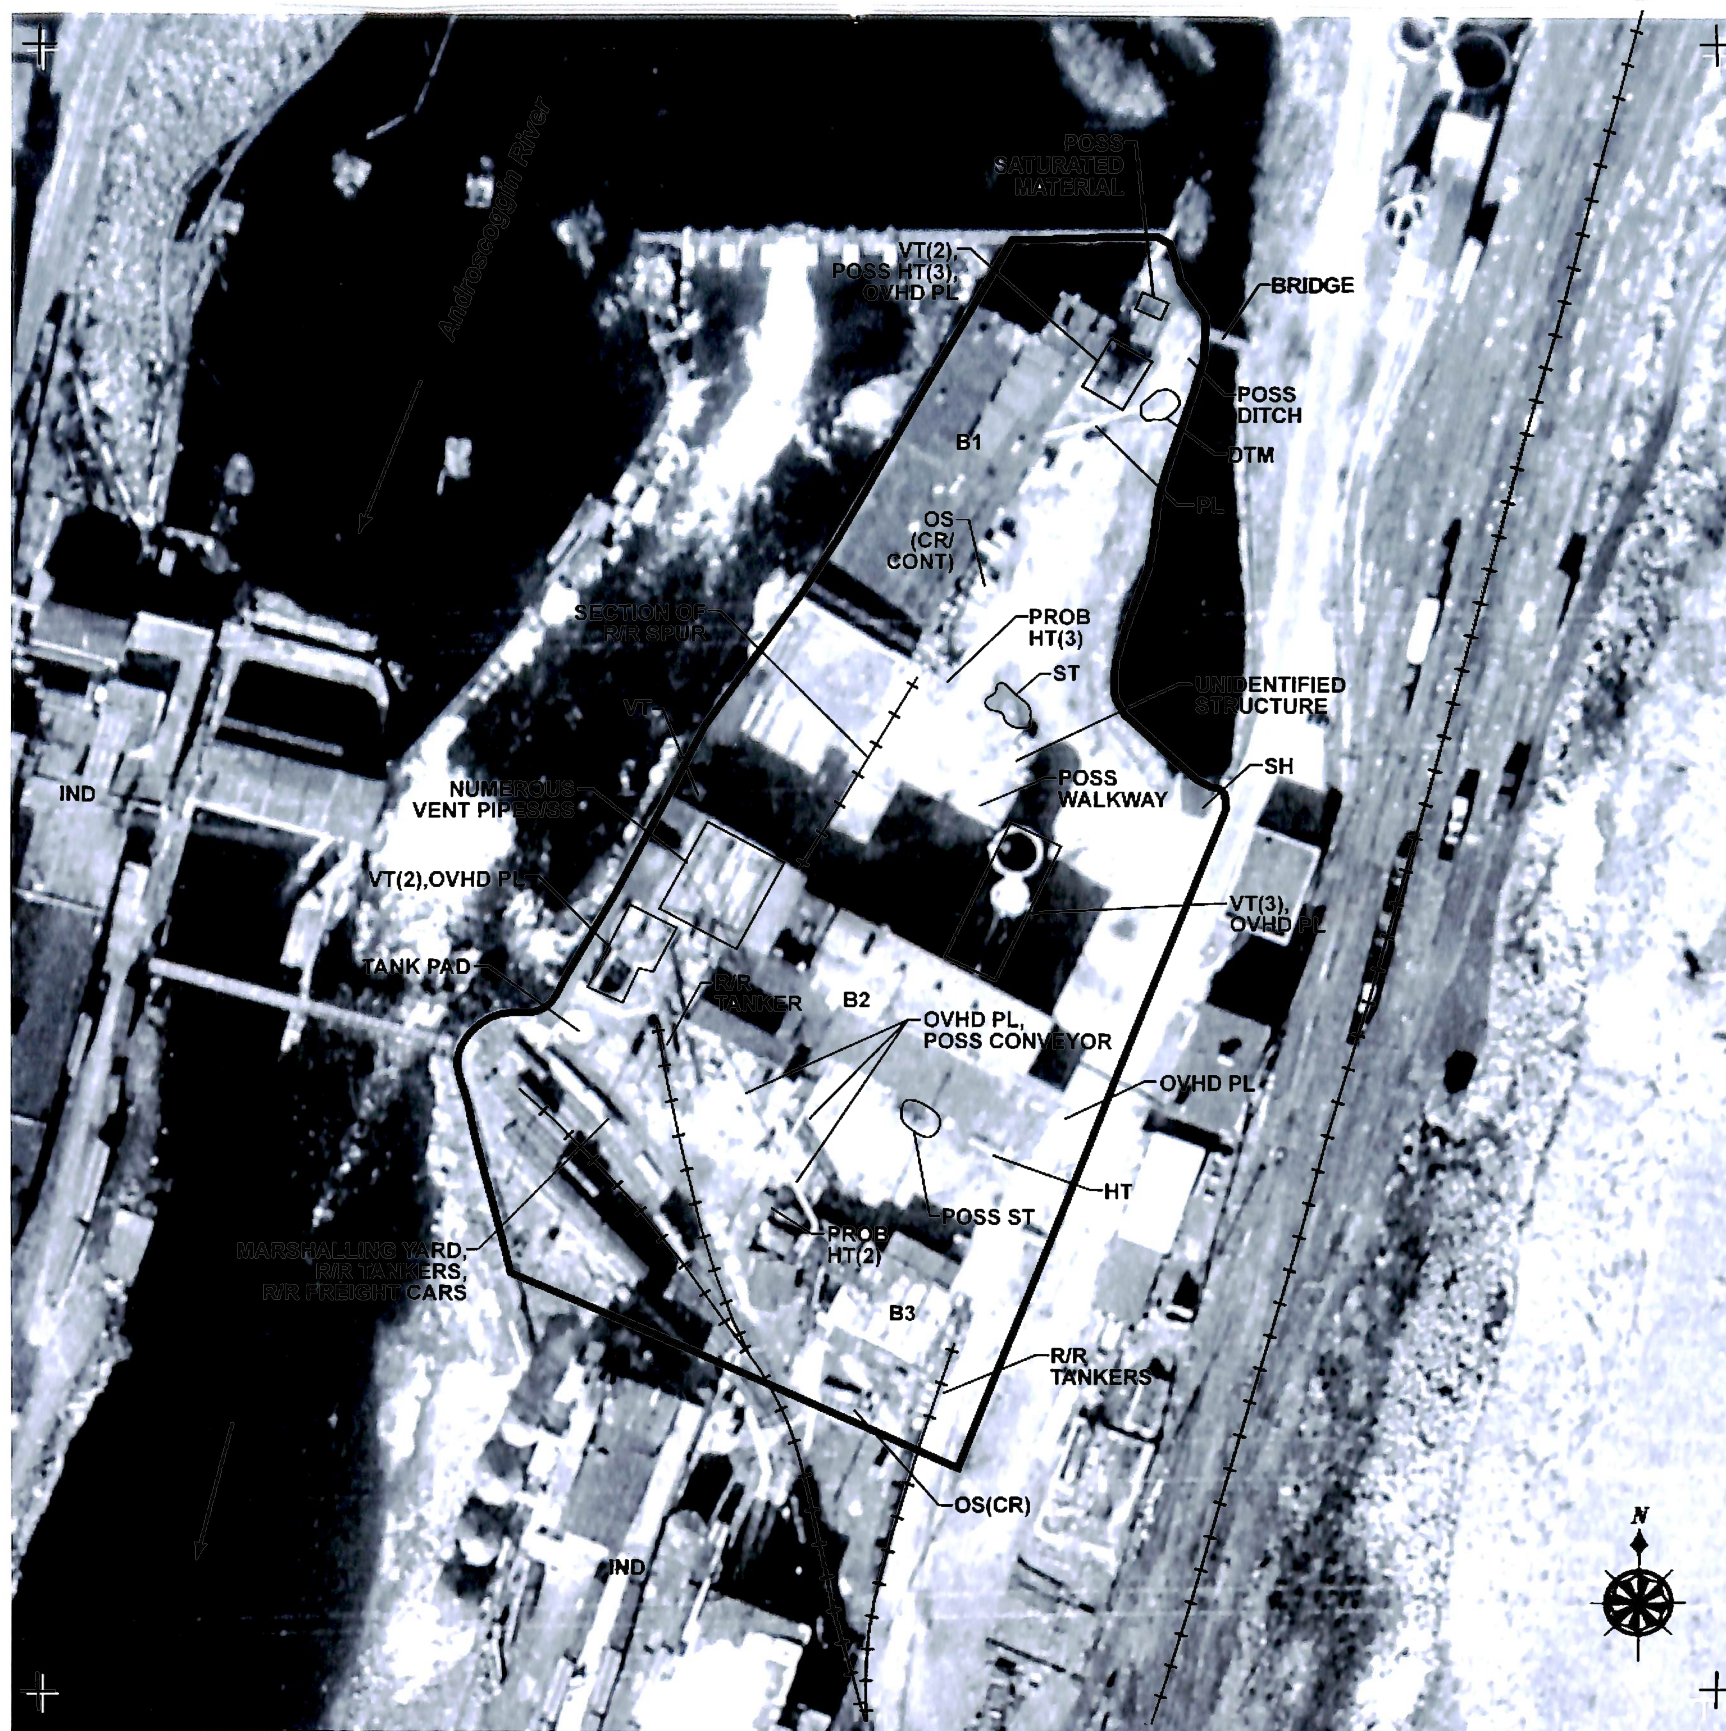
Figure 6. Chlor-Alkali Facility, November 4, 1964. Approximate scale 1:1,475.

NOVEMBER 4, 1964 (FIGURE 6)

Buildings B1, B2, and B3 and the small shed remain at the site. Since 1955 two vertical storage tanks and three possible horizontal storage tanks (HT) have been placed along the east side of building B1. The tanks appear to be connected to building B1 by a lattice of overhead pipelines. Just to the north is a rectangular-shaped area of possible saturated material. A pipeline extends northeast from building B1 to a possible ditch which terminates at the edge of the waterway near the walking bridge. At the connection point of the pipeline and possible ditch is a patch of dark-toned material (DTM) or stain (not annotated), suggesting a collection point for liquid. The open storage area, located along the east wall of building B1, now houses crates (CR), containers (CONT), and a grouping of three probable horizontal storage tanks. A section of a railroad track, likely a remnant of a dismantled rail spur, is visible between buildings B1 and B2. Due to the relatively lower film resolution of the 1955 photograph it is not possible to ascertain if this feature is in place at that time.

Numerous vent pipes and smokestacks (SS) are noted protruding from the roof of the western section of building B2. Connected to building B2 by overhead pipelines are two groupings of two vertical storage tanks. The storage tanks located on the north side of the building were visible in 1955. Near the tanks is a light-toned possible walkway which likely extends from the building, to an unidentified structure and adjacent stain (ST). The function of this structure cannot be determined. A grouping of two vertical storage tanks is located alongside the Androscoggin River. In 1955, three probable vertical storage tanks were observed at this location. Since 1955, one storage tank has been removed, a circular-shaped tank pad remains. A vertical storage tank remains in place on the northeast side of building B2 and a horizontal storage tank is now located on southeast side of the building. Building B2 is connected to an offsite building (not annotated), located due east of the site, via an overhead pipeline. Additional overhead pipelines or possible conveyors connect building B2 to building B3. An open storage area consisting of small crates, and two probable horizontal storage tanks is located near building B3.

Numerous railroad tanker cars are parked in the marshalling yard and adjacent to buildings B2 and B3.

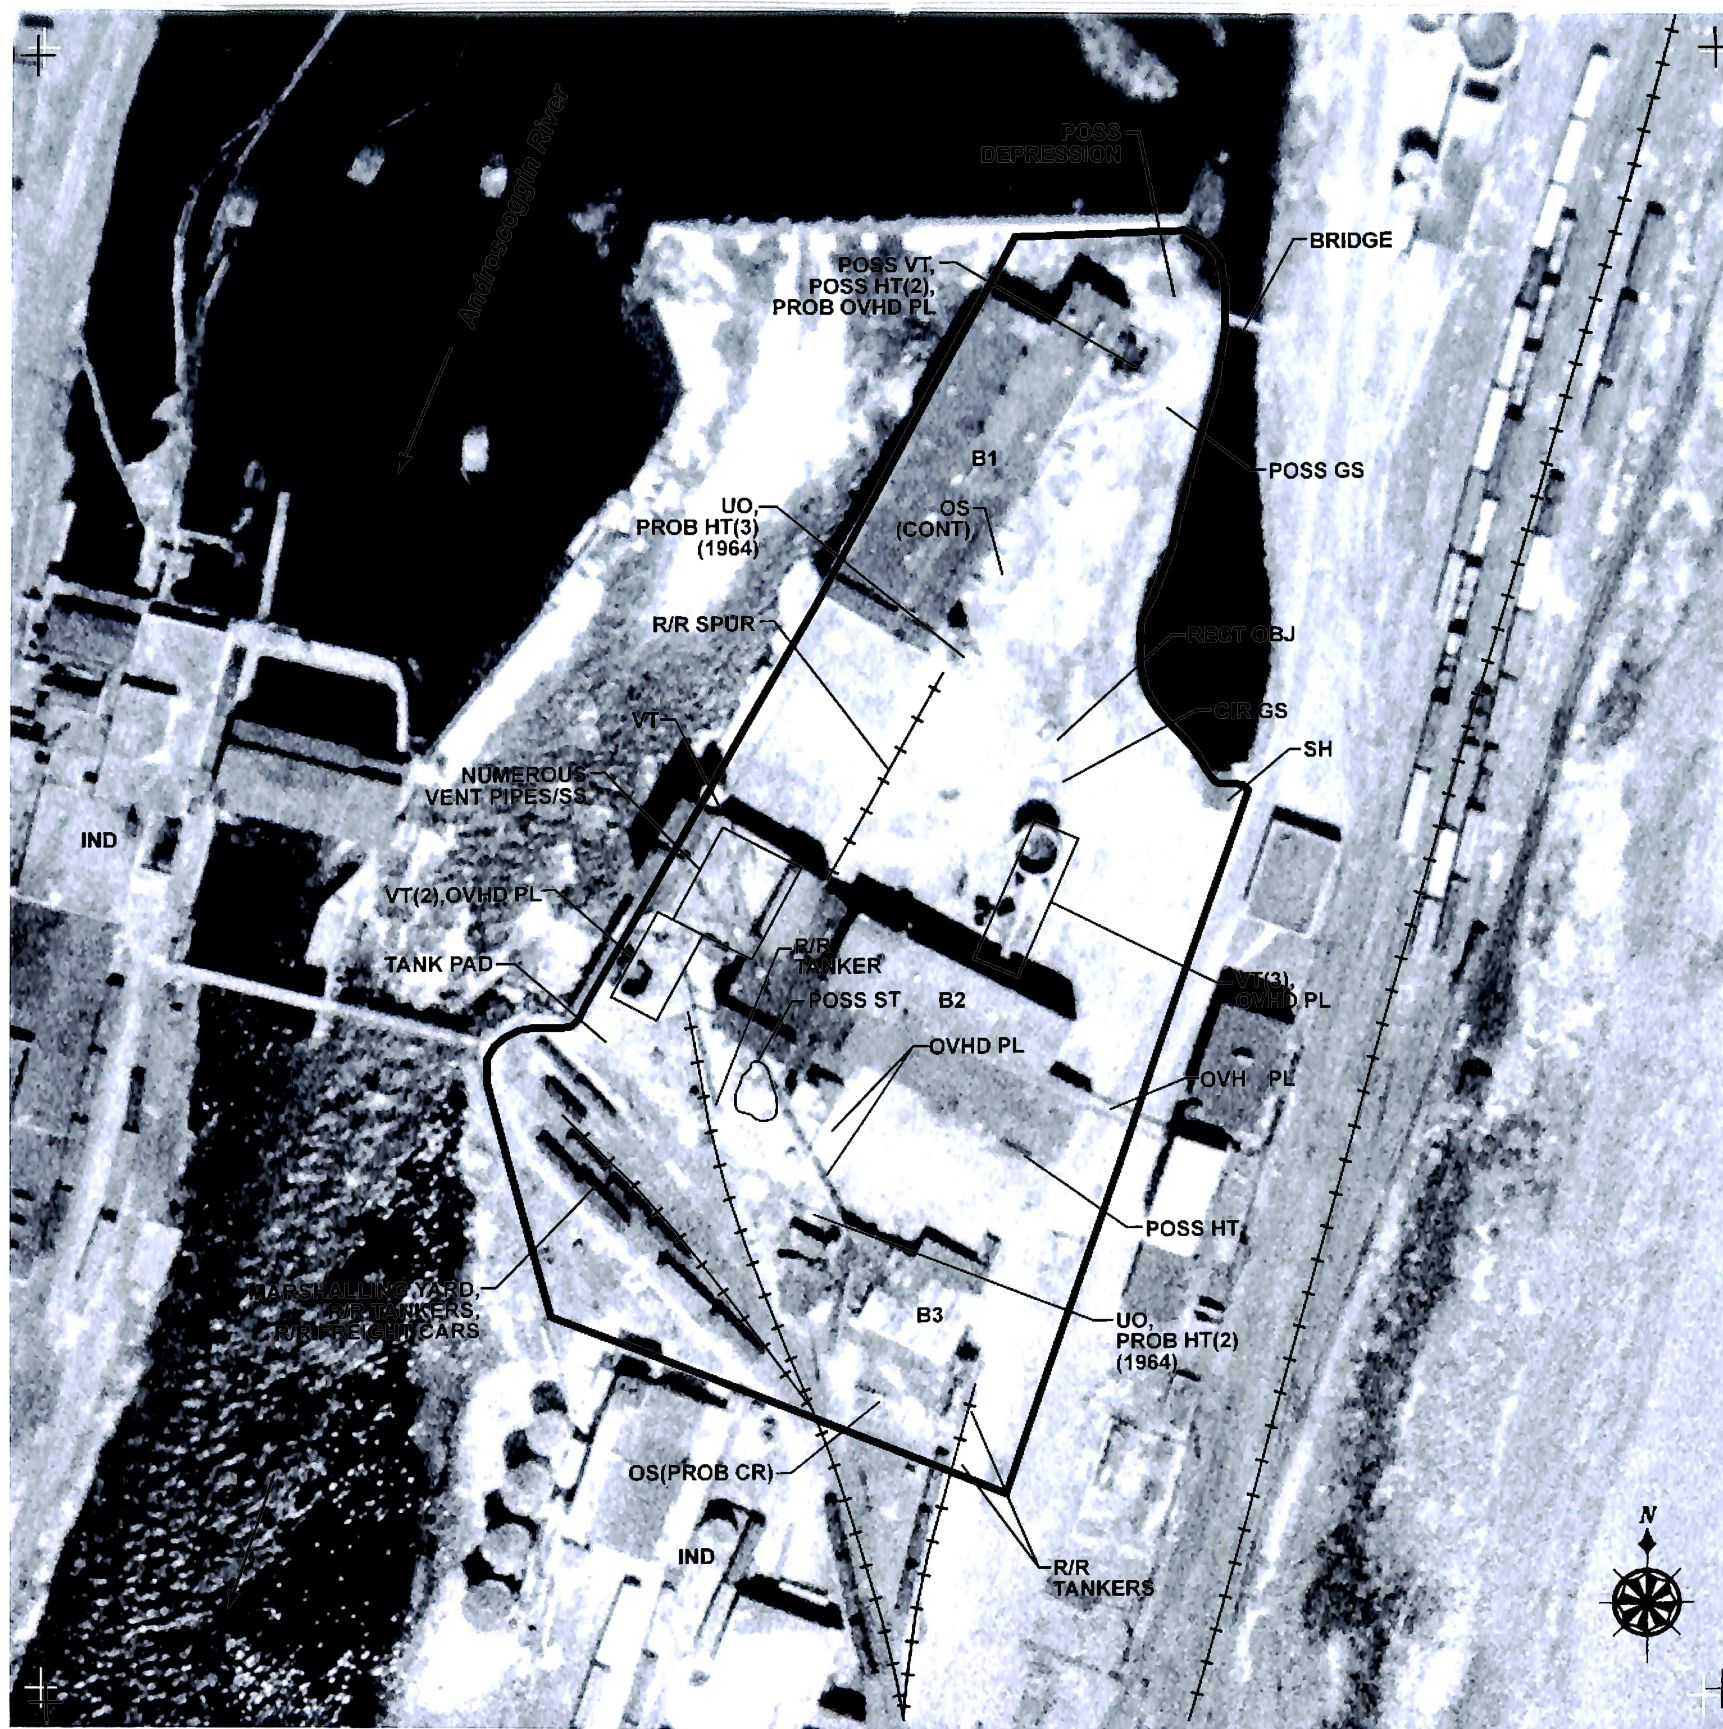
Figure 7. Chlor-Alkali Facility, May 6, 1965. Approximate scale 1:1,475.

MAY 6, 1965 (FIGURE 7)

Buildings B1, B2, and B3 and the small shed remain visible at the site which does not appear to be active at this time. Connected to building B1 by a lattice of probable overhead pipelines are a possible vertical storage tank and two possible horizontal storage tanks. A linear, possible ground scar extends from the building to near the bridge. In 1964, a pipeline, possible ditch, and a patch of dark-toned material were noted at this location. Near the bridge there is a rectangular-shaped possible depression; in 1964 possible saturated material was noted at this location. Containers remain at the open storage area and an unidentified object (UO) is located alongside building B1 at the terminus of the railroad spur remnant. This unidentified object is approximately one-half the height of building B1 and located near to where three probable horizontal storage tanks were seen in 1964.

The grouping of three vertical storage tanks (one of which is open-topped) and a connecting overhead pipeline remain on the north side building B2. Just north of these storage tanks are a rectangular-shaped object (REC OBJ) and a circular-shaped ground scar (CIR GS). The symmetry of this ground scar suggests the former location of a storage tank, but no tank was observed at the location in 1955 or 1964. The grouping of two vertical storage tanks (one of which appears open-topped), overhead pipelines, and large-diameter tank pad remain in place alongside the Androscoggin River. The vertical storage tank located on the northwest side of building B2 remains in place and a possible horizontal storage tank is noted alongside the southeast side of the building. Building B2 remains connected to an offsite building (not annotated) via an overhead pipeline and overhead pipelines continue to connect building B2 to building B3. Adjacent to building B3 is the open storage area housing small probable crates. Also noted near this building is an unidentified object where in 1964, two probable horizontal storage tanks were observed.

In the railroad marshalling yard there are numerous parked railroad tanker cars and several freight cars. Additional railroad tanker cars are located adjacent to building B3.

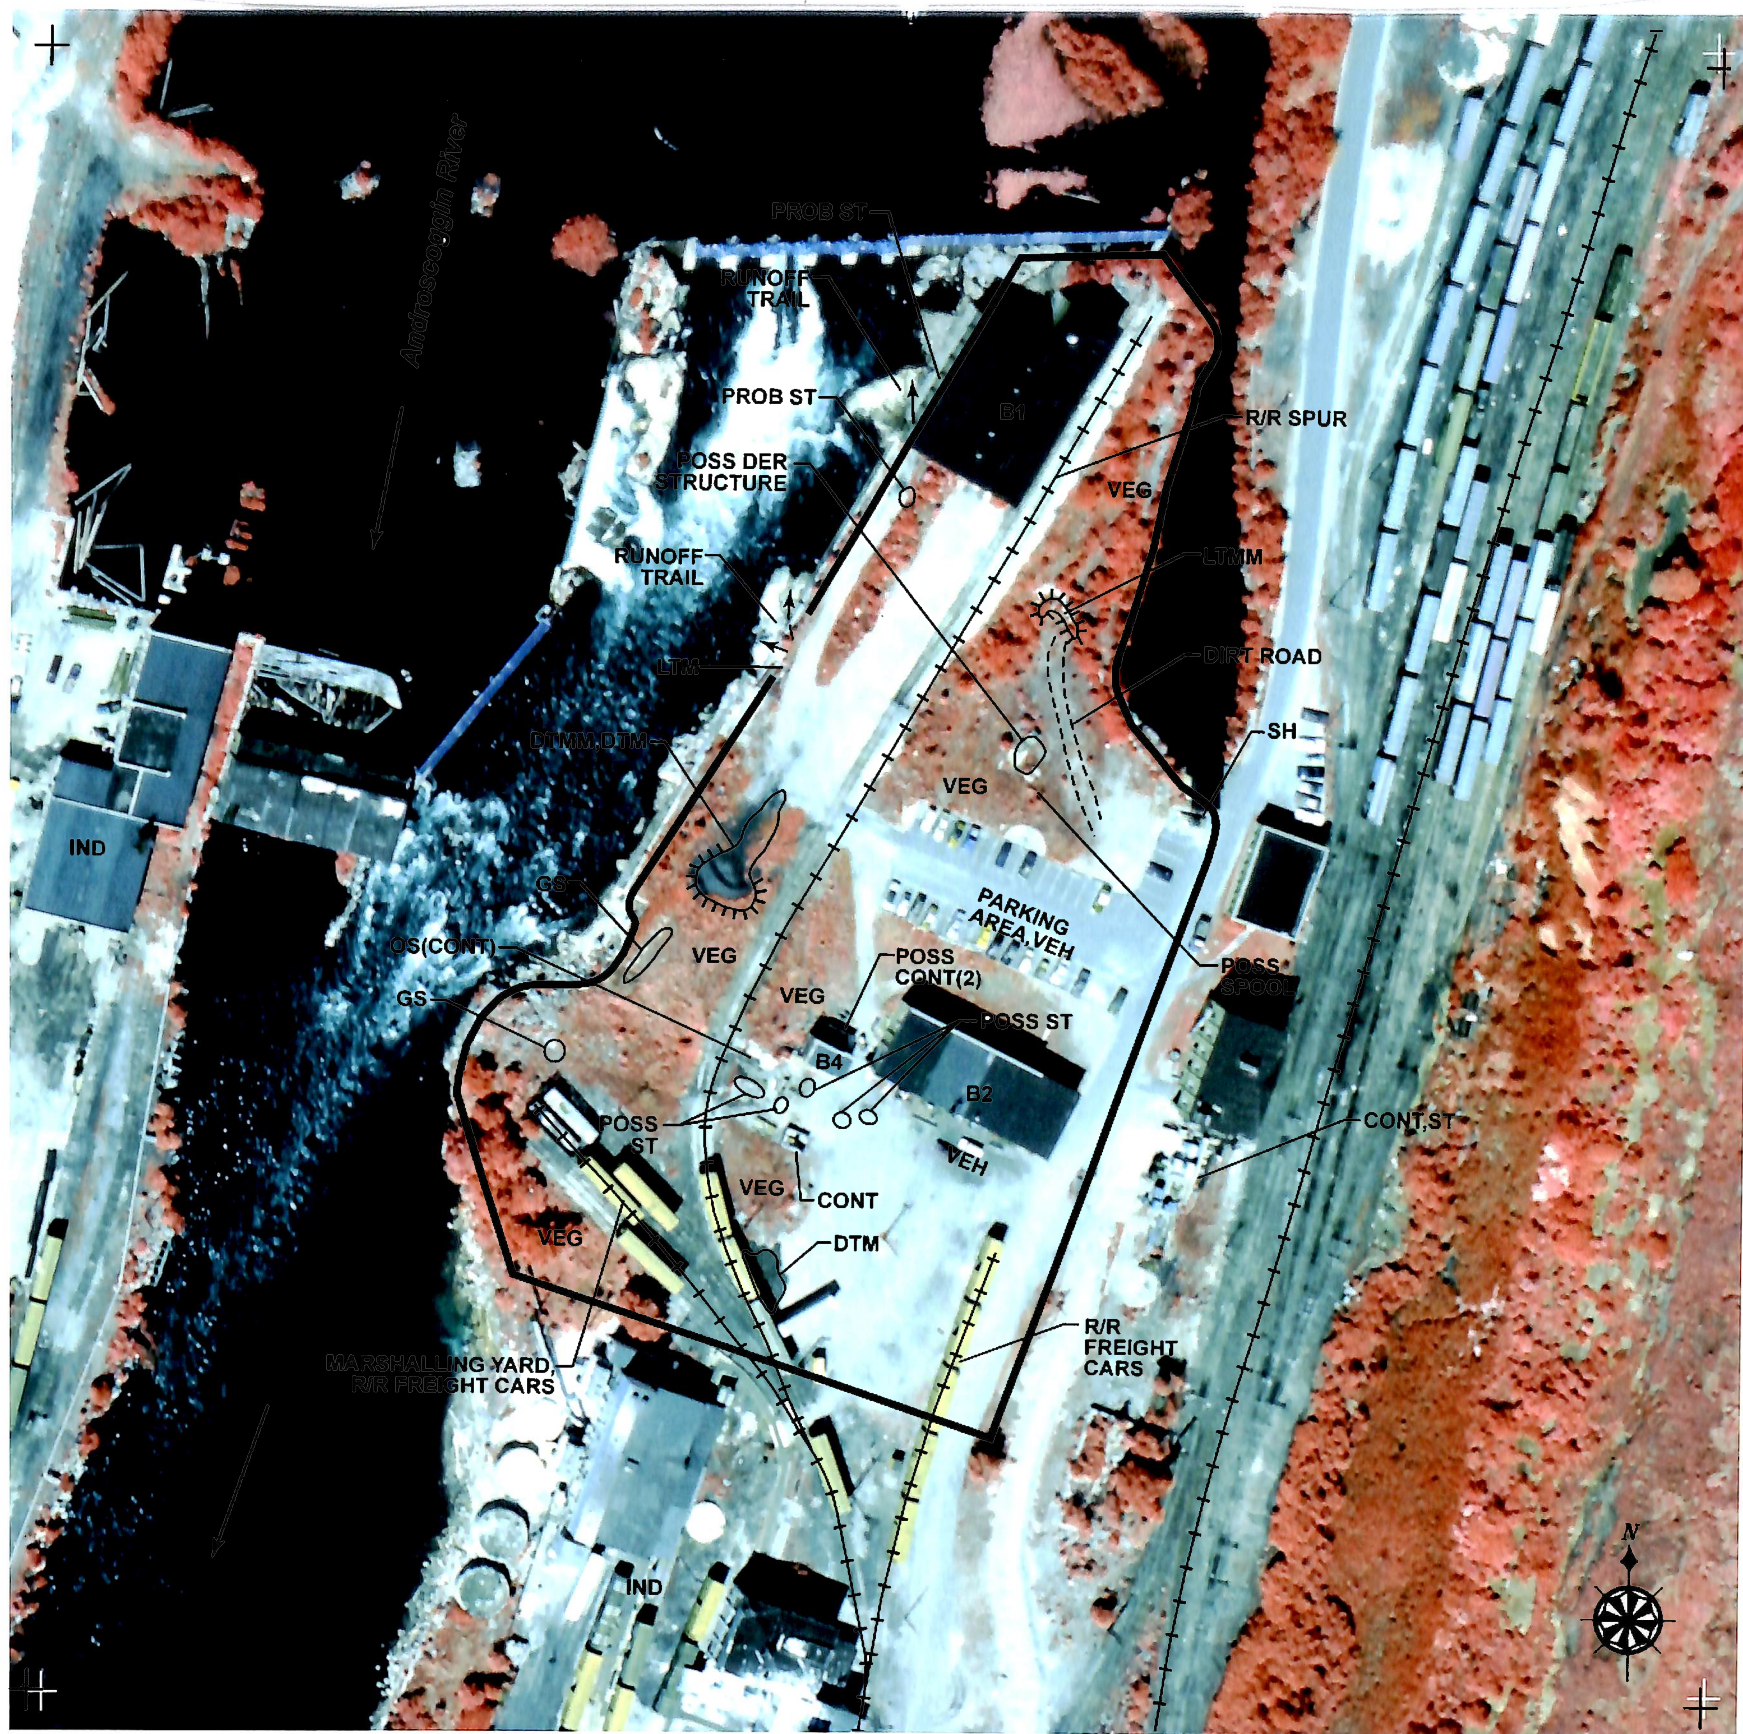
Figure 9. Chlor-Alkali Facility, August 19, 1976. Approximate scale 1:1,485.

AUGUST 19, 1976 (FIGURE 9)

There are no changes noted to buildings B1, B2, B4 or the shed, but the walking bridge has been removed. Near building B1 there is a probable ground stain on an entrance road (not annotated) into the building. On the retaining wall of the building just above the Androscoggin River, there are two probable stained areas (annotated as one feature due to scale) that appear to emanate from the retaining wall. On two rock outcrops (not annotated) in the river there are darkened runoff trails. One of these runoff trails appears to originate alongside the building. West of the railroad spur there are uniform light-toned material, a combination of uniform dark-toned material and dark-toned mounded material (DTMM), and ground scars. Numerous freight cars are visible in the railroad marshalling yard.

East of the railroad spur there is a narrow dirt road that extends to a mound of light-toned material which was also noted in 1969. Most of the material seen in this area in 1969 has either been removed or cannot be discerned due to vegetation cover. Adjacent to the dirt road are a possible derelict (DER) structure, possibly part of a loading platform, and a large diameter spool likely used for cable. Numerous vehicles (VEH) are located near building B2, indicating activity at the site.

Near buildings B2 and B4 are patches of possible stained ground and an open storage area where light-toned containers are visible. A large, square-shaped container and two possible containers are also observed near these buildings. Near the railroad spur is a patch of dark-toned material.

At an offsite location there are numerous containers and stained ground.

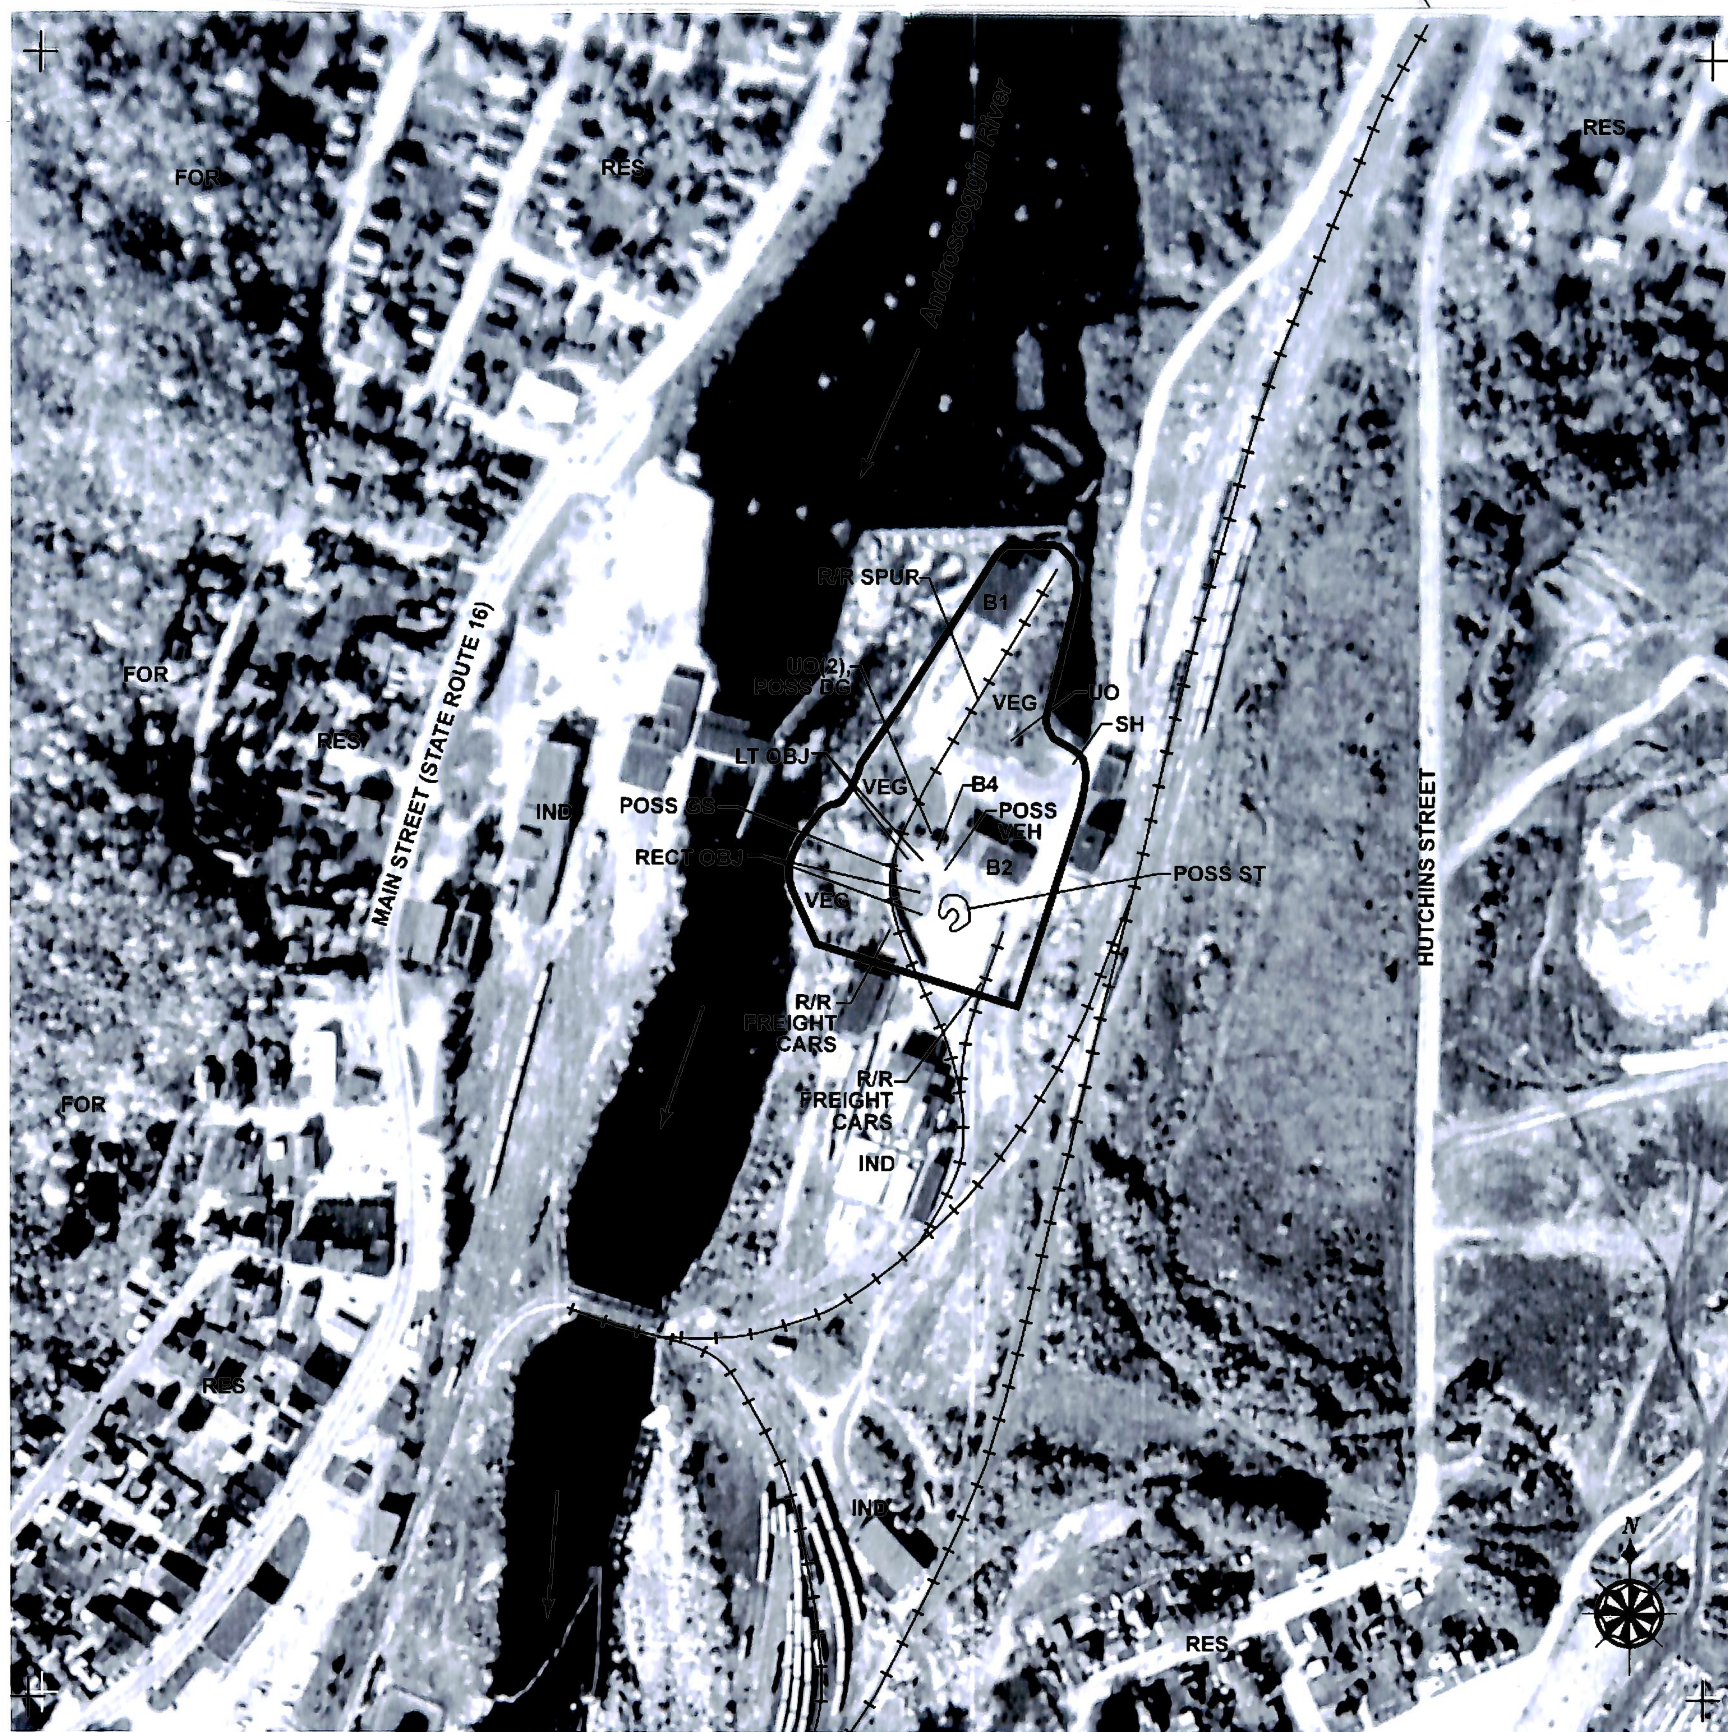
Figure 10. Chlor-Alkali Facility, October 11, 1982. Approximate scale 1:3,600.

OCTOBER 11, 1982 (FIGURE 10)

The 1982 photographs have less resolution than other photographic coverages used in this report. Therefore, features visible on photographs from the other coverages may not be discernible on the 1982 photographs and the following analysis is not as detailed.

There are no changes noted to buildings B1, B2, B4 or the shed. Railroad freight cars have been removed from the marshalling yard and this yard (railroad ties) has been dismantled. Vegetation areas throughout the site appear unkempt and one possible vehicle is present but the facility is no longer active.

No significant environmental activity is noted west of the railroad spur. East of the railroad spur are several unidentified objects, light-toned objects, and rectangular-shaped objects. These objects range in size from a large truck to approximately one-half an automobile. Possible ground scars, possible disturbed ground, and possible stained ground are also noted.

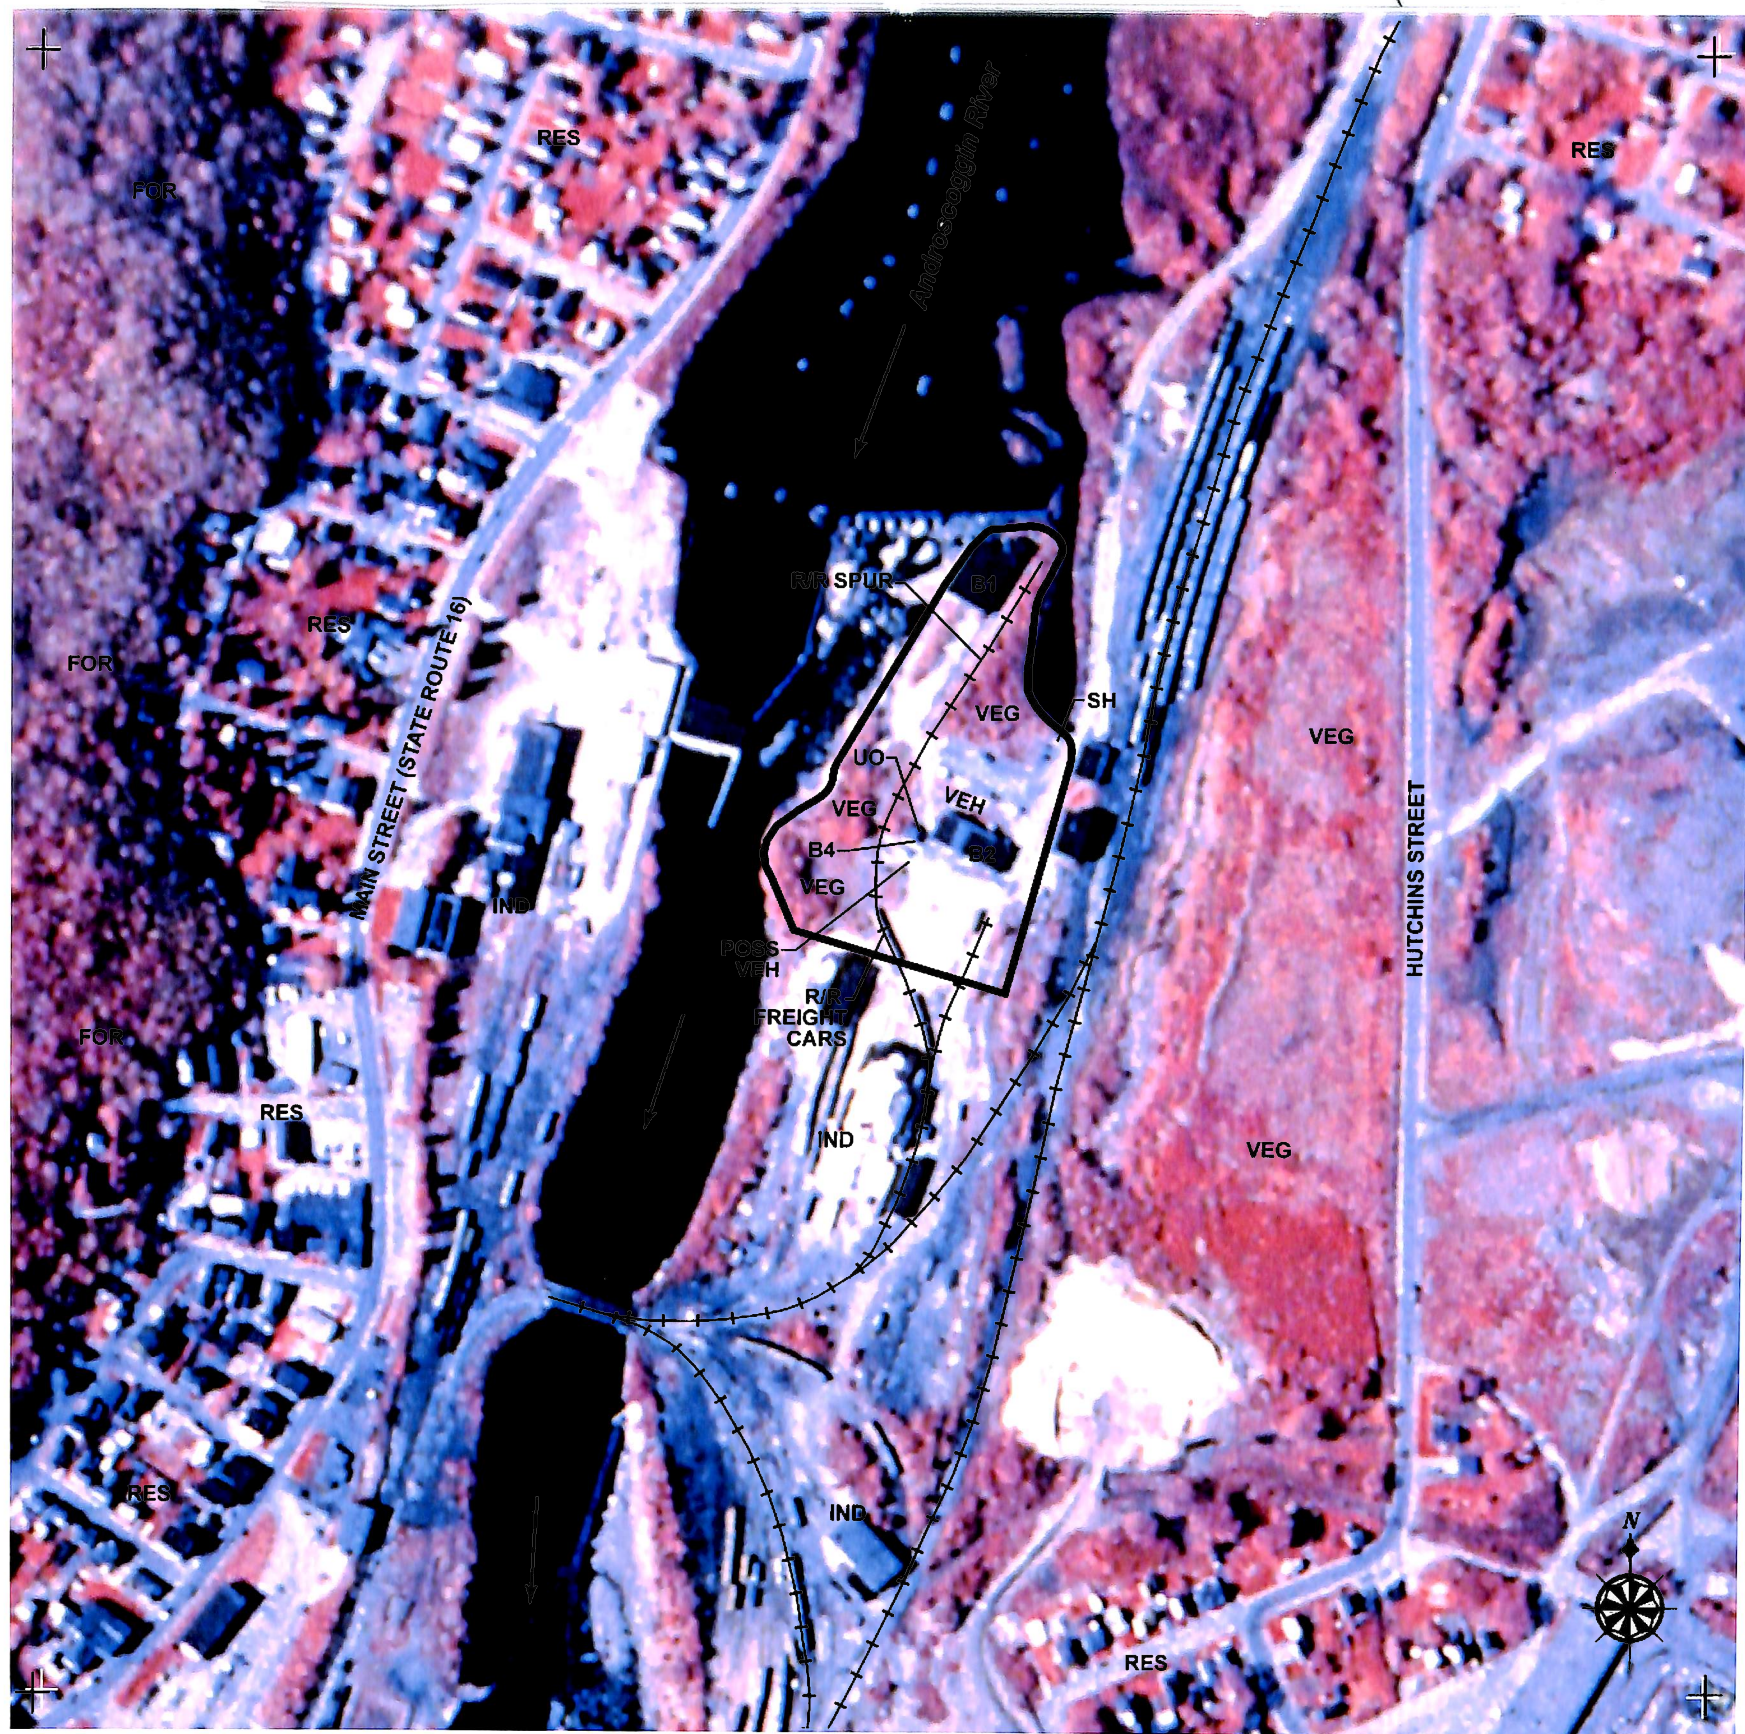
Figure 11. Chlor-Alkali Facility, May 13, 1986. Approximate scale 1:3,560.

MAY 13, 1986 (FIGURE 11)

The 1986 photographs have less resolution than other photographic coverages used in this report. Therefore, features visible on photographs from the other coverages may not be discernible on the 1986 photographs and the following analysis is not as detailed.

There are no changes noted to buildings B1, B2, B4 or the shed. Vegetation areas throughout the site appear unkempt. Several vehicles, a possible vehicle, and railroad freight cars are visible on the railroad spur but the facility is no longer active.

No significant environmental activity is noted west of the railroad spur. East of the railroad spur is an unidentified object approximately one-half the size of an automobile.
